# Intel® Celeron® Processor in the 478-Pin Package

Specification Update

*September 2003*

Document Number: 290749-014

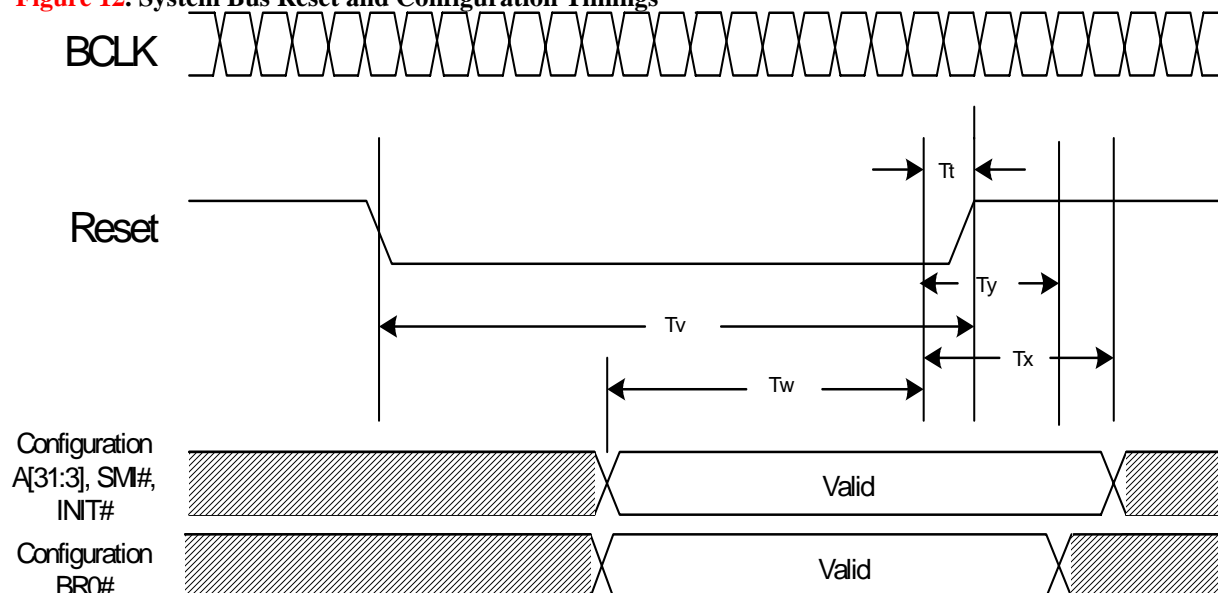
**Figure 12. System Bus Reset and Configuration Timings**

The BR0# maximum hold time has changed to 2 BCLKs. This change will be shown in the “System Bus AC Specifications (Reset Conditions)” table and “System Bus Reset and Configuration Timings” figure of the *Intel (R) Celeron (R) Processor on .13 Micron Process in 478-Pin Package Datasheet*. This change will be incorporated in the next revision of the Datasheet.
